1313 Mockingbird Lane Anger, NC

Iron Homes Inspections LLC 17 Fielding Ct Durham, NC 27703

Report Number:

103120190900

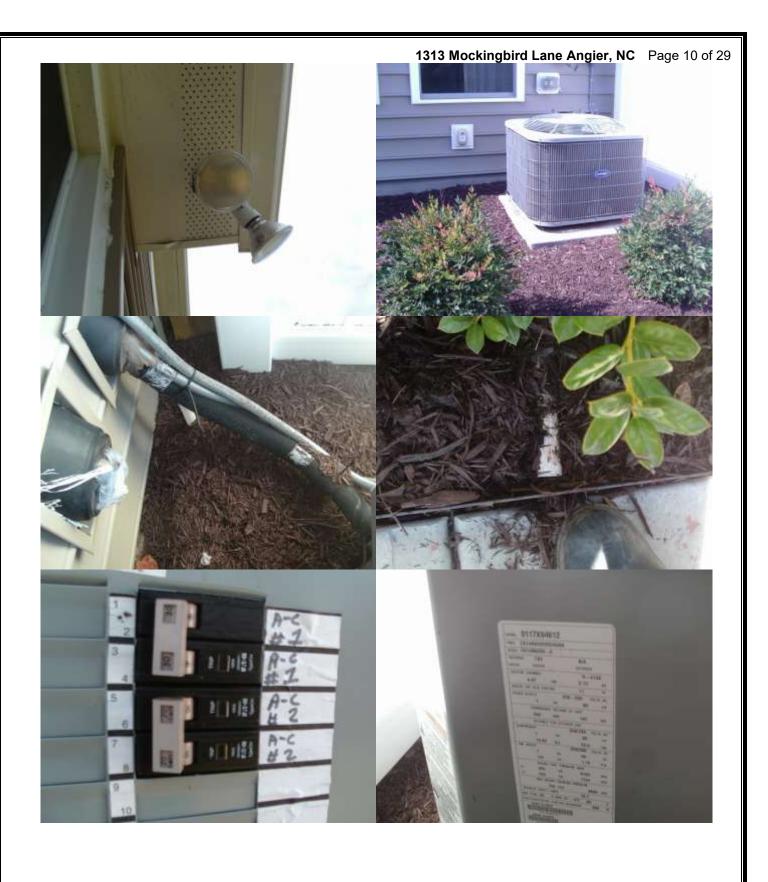
done the drainage line is likely to be blocked and may result in backup of condensate material damaging
the interior portion of the HVAC system. (See photos)
(Comment 10-3) the exterior is set up for the presence of two air conditioning units. However the
remaining air conditioning unit appears sized correctly for the square footage of the home. It is
recommended that an HVAC technician fully evaluate and ensure that the remaining air conditioning
system is properly set up for the home utilizing baffles and a diverting computer to properly zone the home.
(See photo)

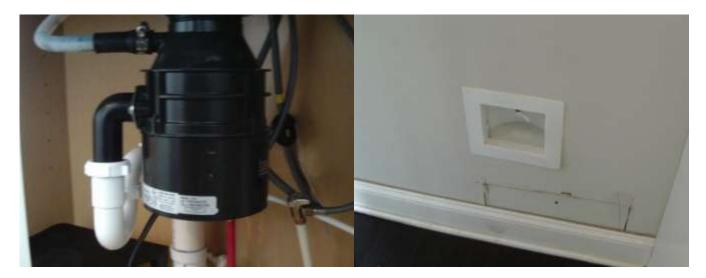
☑ Disposal Operable	1 9 /
	e: ☑ Yes ☐ No ☑ Exhaust fan Operable: ☑ Yes ☐ No
•	e: ✓ Yes □ No ✓ Refrigerator Operable: ✓ Yes □ No
☑ Dishwasher <i>Operable</i>	
□ Operable	$e: \square \ \mathrm{Yes} \ \square \ \mathrm{No} \ \square $ Operable: $\square \ \mathrm{Yes} \ \square \ \mathrm{No}$
Dishwasher Airgap:	☐ Yes ☑ No and/or Dishwasher Drain Line Looped: ☐ Yes ☑ No
Receptacles Present:	✓ Yes □ No Operable: ✓ Yes □ No
GFCI:	✓ Yes □ No Operable: ✓ Yes □ No
	☐ Recommend GFCI Receptacles
Open ground/Reverse p	polarity: ☐ Yes ☑ No ☐ Potential safety hazard(s
(Comment 14.1) On the	day of the increation the carbona disposal did not function. It is recommended th
	e day of the inspection the garbage disposal did not function. It is recommended the all fully evaluate and repair or replace as necessary to ensure proper operation of the
11 1	is not done reduced functionality may exist. (See photo)
	day of the inspection the waterline to the refrigerator was not properly attached as

eaks or proper operation. It is recommended that a plumber fully evaluate and e functionality of the water and I system for the refrigerator. (See photo)
property attach to ensure	e functionality of the water and I system for the refrigerator. (See photo)

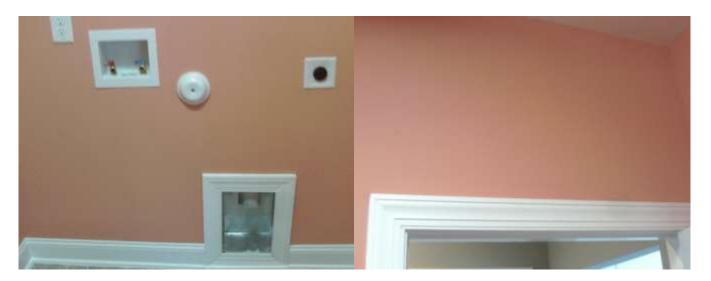
(Comment 16-1) The laundry room is not vented. It is recommended that a neutral air vent be added to a wall or ceiling to ensure no negative air pressure condition can exist in the laundry room. If this is not done laundry room doors may be difficult to operate and or the efficiency of the dryer may be reduced. A ducting professional should do this. (See photo)

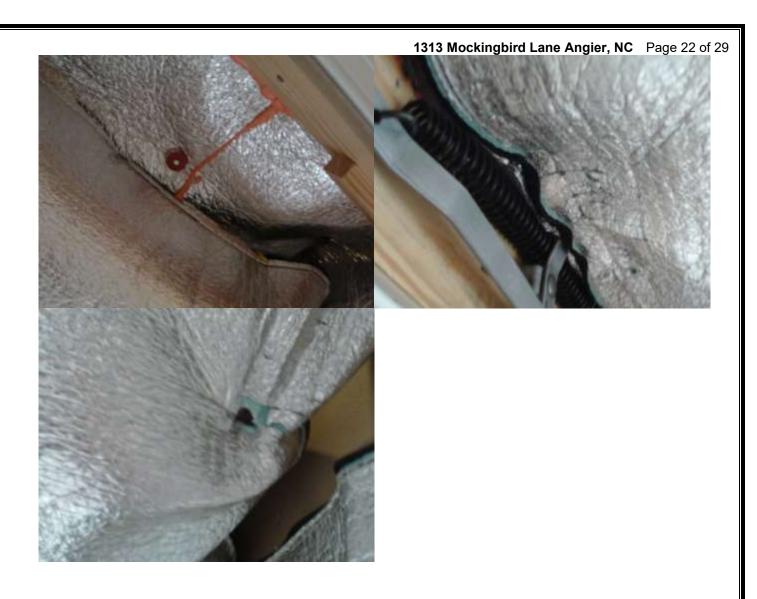
ATTIC/STRU	CTURE/FRAMING/INSU	JLATION	□ N/A (See re	marks)	
Access:	☐ Stairs ☑ Pulldown	☐ Scuttlehole/H	Hatch $\square No$	access	
Inspected From	n: □ Access panel ☑	In the attic			
Location:	☑ Bedroom hall ☐ Bed	lroom closet	☐ Garage		
(Comment 22-1) the insulation tent for the			ecome bound in the spri	ings of the
	recommended that an insula				
	nsulation tent has rendered				
	lation that was intended has				•
			`	• /	
Flooring:	☐ Complete ☑ Pa	rtial	□ None		
Insulation:	☑ Fiber glass ☐ Ba	tts 🗹 Loose	☐ Cellulose	☐ Foam	
	☐ Vermiculite ☐ Ro	ockwoll	Depth: 12-	H	
	☐ Recommend Baffles @	Eaves	_		
	□ Damaged □ Displace	ced \square Missin	g 🗆 Compre	ssed	
Installed In:	☐ Rafters ☐ Walls	Between ceili	ng joists 🔲 U	Inderside of Roof Deck	(
	☐ Not visible				
	☐ Recommend additiona	l insulation (Se	e comments)		
Vapor Barrier	s: Kraft/foil faced	☐ Plastic 🗹 N	lot visible □	Improperly Installed	
Ventilation:	☑ Ventilation appears ade	equate	□ Recommen	d additional ventilation	n

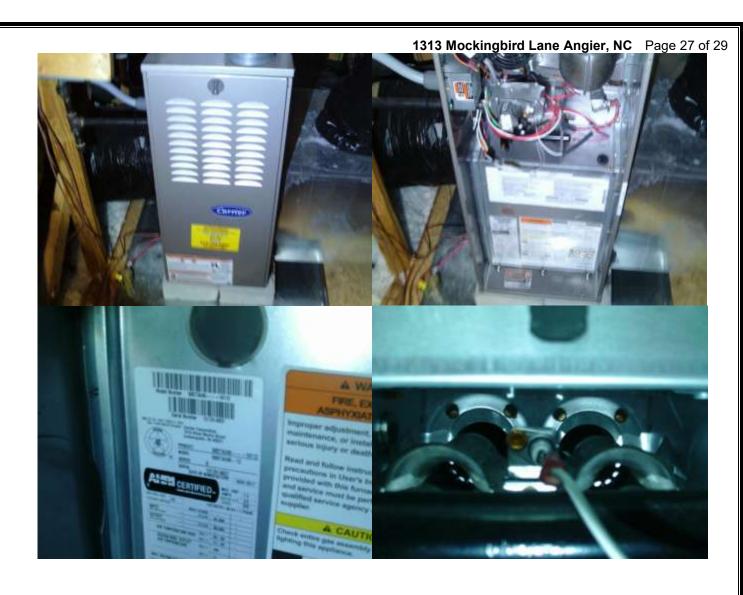
tion: ☐ Satisfactory ☑ Marginal ☐ Poor ☑ Recommended HVAC Technician	
	ed Due To: Exterior temperature	
(Comment 27-1) it is noted that when the air conditioning or heating is on in the first floor air is coming from the vents on both floors. This may denote and improperly programmed diverting computer or a damaged or nonfunctional baffle. It is recommended that an HVAC technician fully evaluate and repair or replace as necessary in order to ensure proper and full operation of the zone heating and air-conditioning systems. If this is not done this may result in an over heating or cooling of the second floor as well as a delayed heating or cooling of the first		
floor.
