1313 Mocking Bird Lane, Raleigh, NC 27609

**Inspection Date:**  
01/01/2014

**Prepared By:**  
Iron Homes Inspections LLC  
17 Fielding Ct  
Durham, NC 27703

**Report Number:**  
090920141300

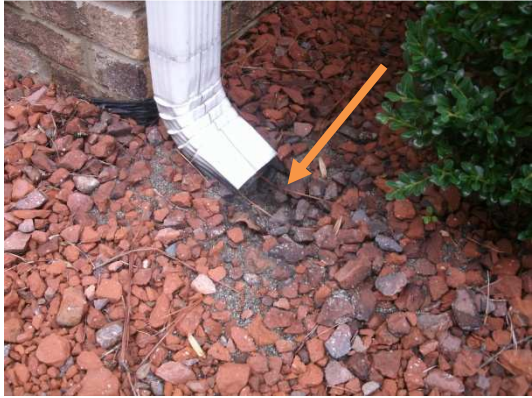
In the north east corner of the building there is not gutter extension at the end of the downspout this is causing erosion in the flower bed and excess moisture against the structure. Recommend that an extension is placed at the end diverting it out of the flower bed and away from the foundation to avoid problems in the future. (Picture left first row)

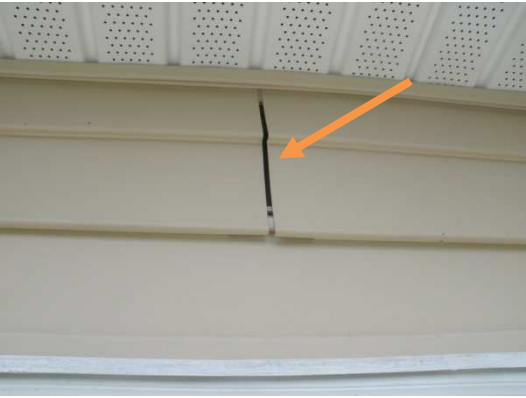
There is a gap in the siding on the rear of the home, this is a possible pest and moisture entry point and should be repaired or replaced to eliminate the possibility of this in the future. (Picture first row right)

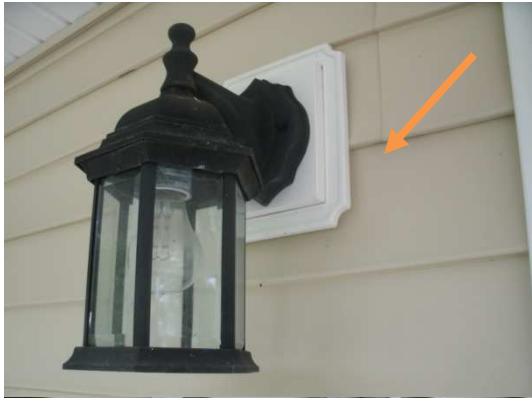
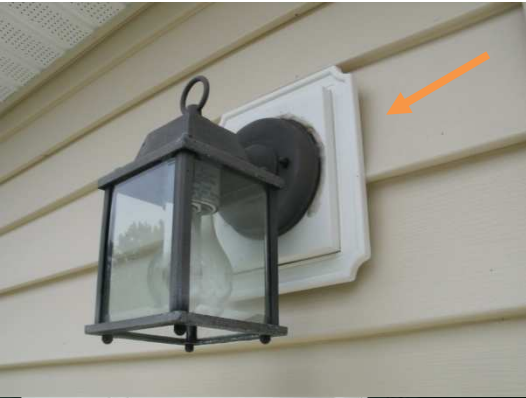
Light fixtures on front and back of house are not properly attached to structure and are now sagging down causing a warping in the vinyl siding. These should be attached to structure to avoid future damage to siding and also eliminate a possible electrical short issue with the light fixtures. (Pictures second row)

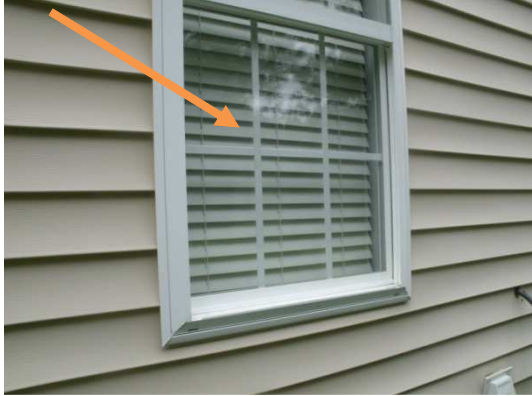
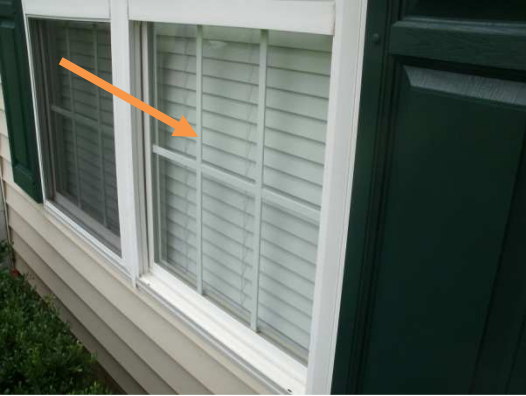
Two screens missing on home one on left side of home and one on the front of the home, these should be replaced to avoid pest infiltration into home when the window is open. (Picture third row)

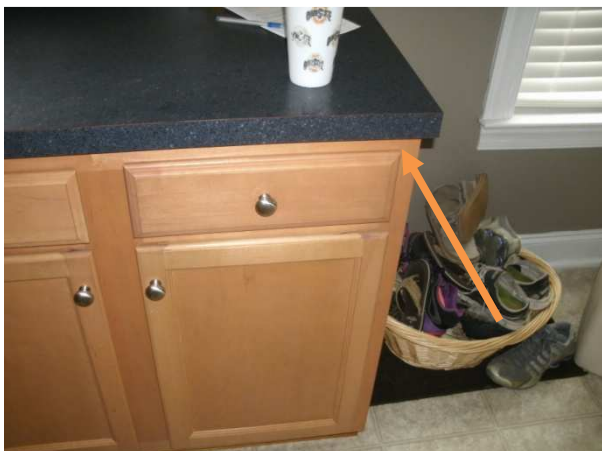
Countertop to the right of the sink is not attached to cabinets and is very loose would recommend securing it to the cabinets to avoid any injury while using countertop. (Picture left)

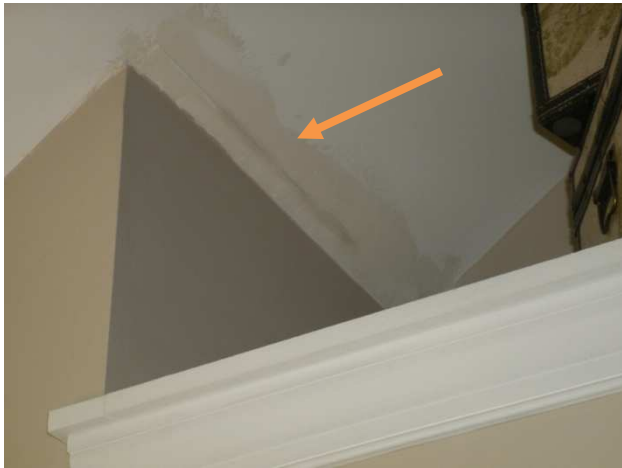
Moisture stain to the left of the front door over the closet upon inspection in attic no clear source for the moisture is present should be monitored for future dampness. (Picture below left)

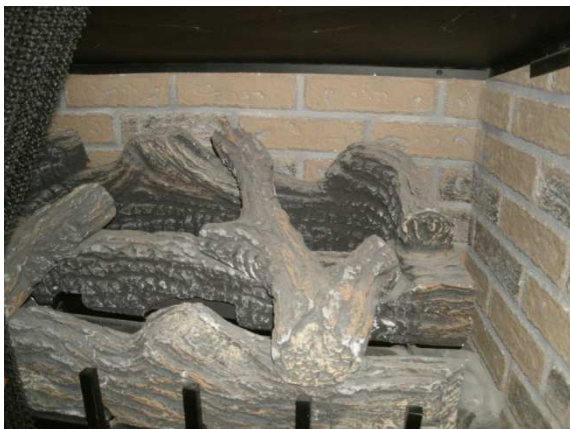
It is recommended that a CO detector is installed in the house there is a vent less fireplace on premises and is a potential source for CO. CO is a odorless and colorless gas that can cause hypoxia and if continued exposure even death. It is for this reason that a CO detector is highly recommended.

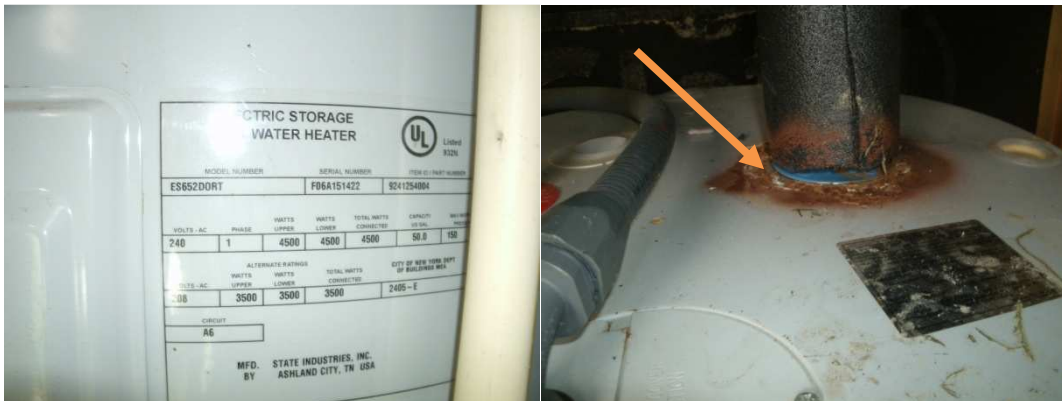
There are signs of rust on the cold water intake area of the water heater this does not affect function today however should be monitored for future effect.

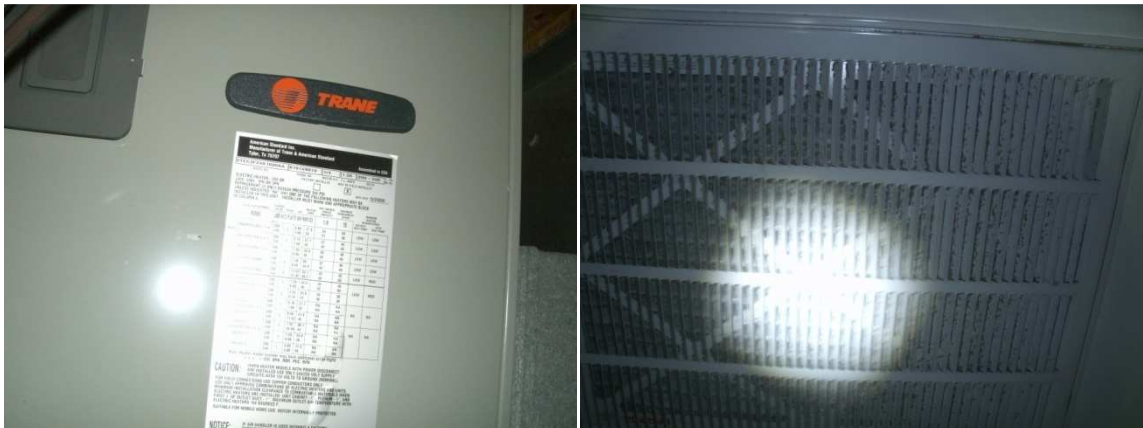
Filters should be replaced as often as needed however a good practice is to change them every 90 days. This will not only reduce the overall dust in the home, however also decrease the working load pressure on the central drive fan causing the entire home’s HVAC system to operate longer without needed service.

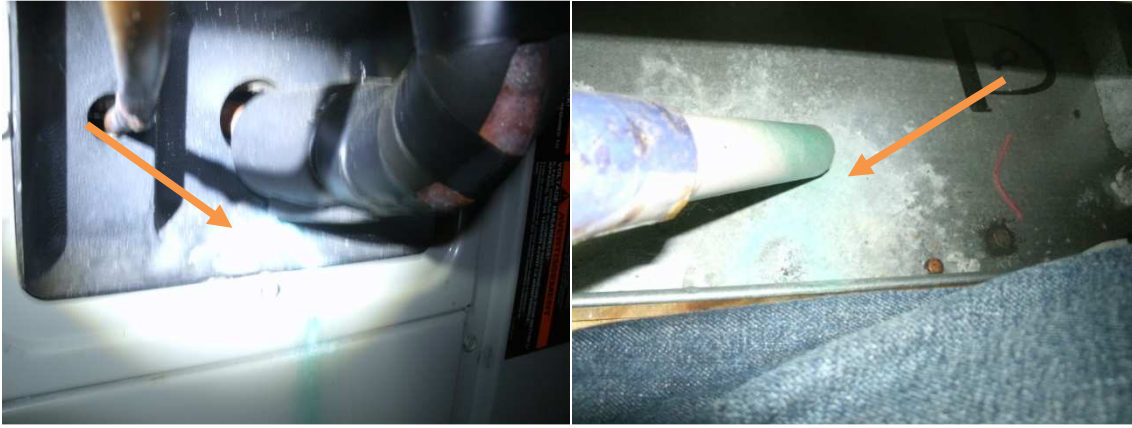
There is a sign of a prior refrigerant leak in the system a HVAC tech should make sure that is not a current issue as this can cause the system to stop functioning suddenly when the pressure in the system no longer is capable of moving heat. (Photo Below)
